**REMOVAL PROGRAM  
PRELIMINARY ASSESSMENT/  
SITE INVESTIGATION REPORT  
FOR THE  
JARD COMPANY, INC.  
BENNINGTON, VERMONT  
17 September 1997**

U.S. Environmental Protection Agency  
Region I  
Emergency Planning and Response Branch  
John F. Kennedy Federal Building  
Boston, MA 02203

Roy F. Weston, Inc. (WESTON®)  
Superfund Technical Assessment and Response Team (START)  
217 Middlesex Turnpike  
Burlington, MA 01803

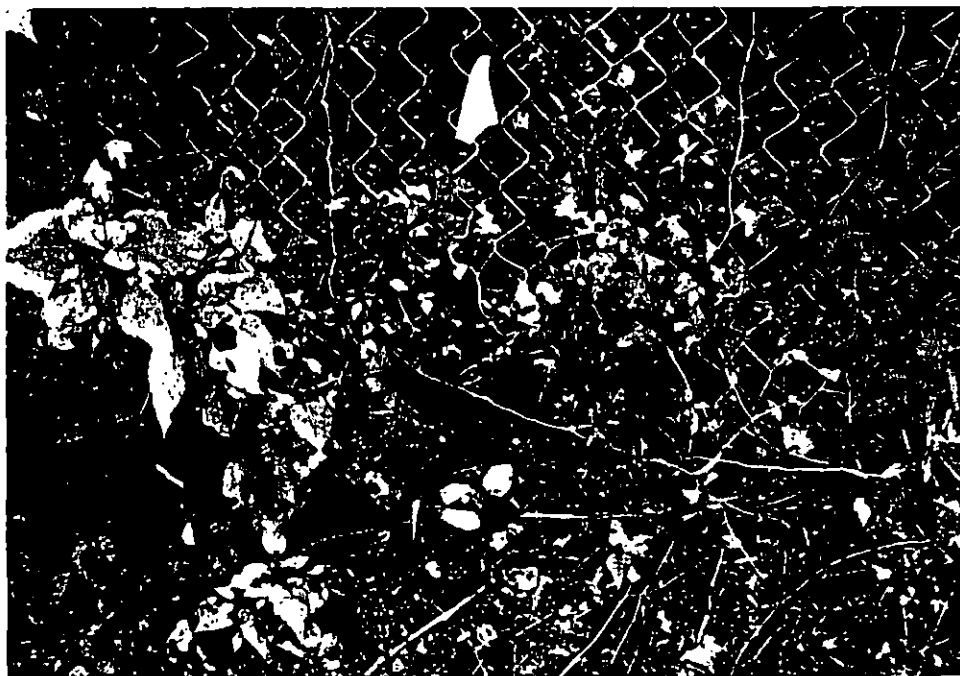
**FRAME NUMBER:** 20 **DATE:** 17 September 1997

**SCENE:** View of soil sampling location SS-07 (facing south).

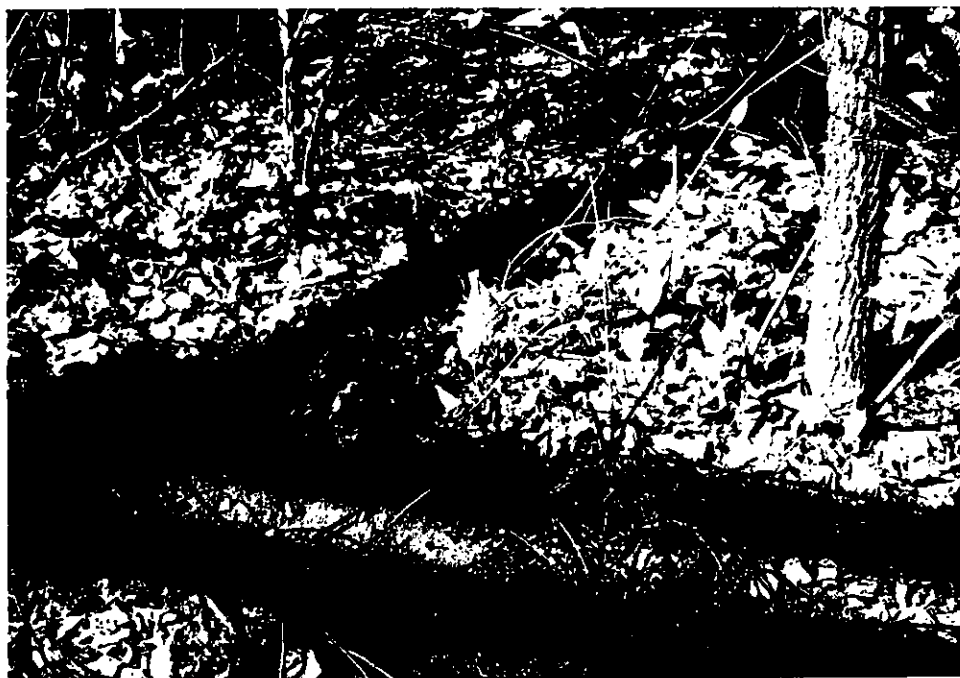
**FRAME NUMBER:** 22 **DATE:** 17 September 1997  
**PHOTOGRAPH BY:** G. Mavris  
**CAMERA:** Olympus **SETTING:** Automatic

**SCENE:** View of soil sampling location SS-05 (facing east).

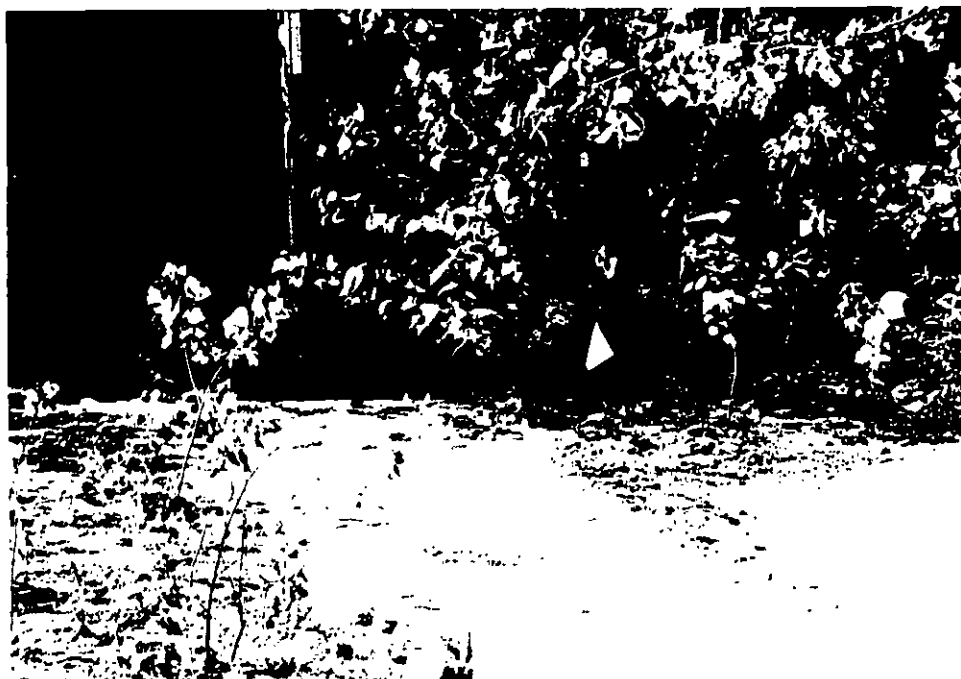
**FRAME NUMBER:** 24 **DATE:** 17 September 1997  
**PHOTOGRAPH BY:** G. Mavris  
**CAMERA:** Olympus **SETTING:** Automatic

**SCENE:** View of soil sampling location SS-08 (facing west).

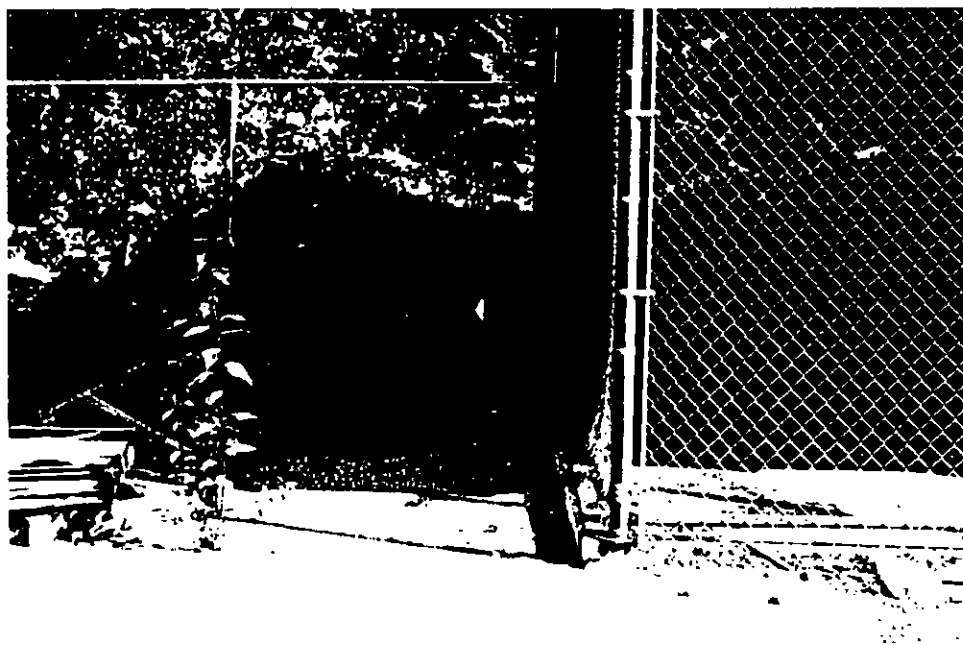
**FRAME NUMBER:** 1 **DATE:** 17 September 1997  
**PHOTOGRAPH BY:** G. Mavris  
**CAMERA:** Olympus **SETTING:** Automatic

**SCENE:** View of soil sampling location SS-10 (facing east).

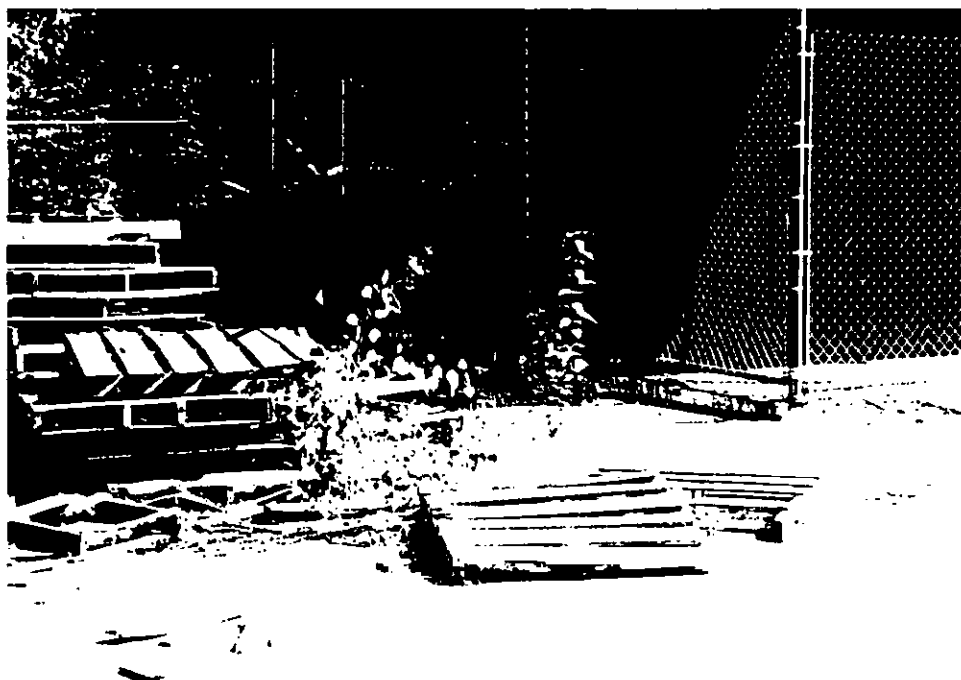
**FRAME NUMBER:** 2 **DATE:** 17 September 1997  
**PHOTOGRAPH BY:** G. Mavris  
**CAMERA:** Olympus **SETTING:** Automatic

**SCENE:** View of soil sampling location SS-10 and former drum storage area (facing east).

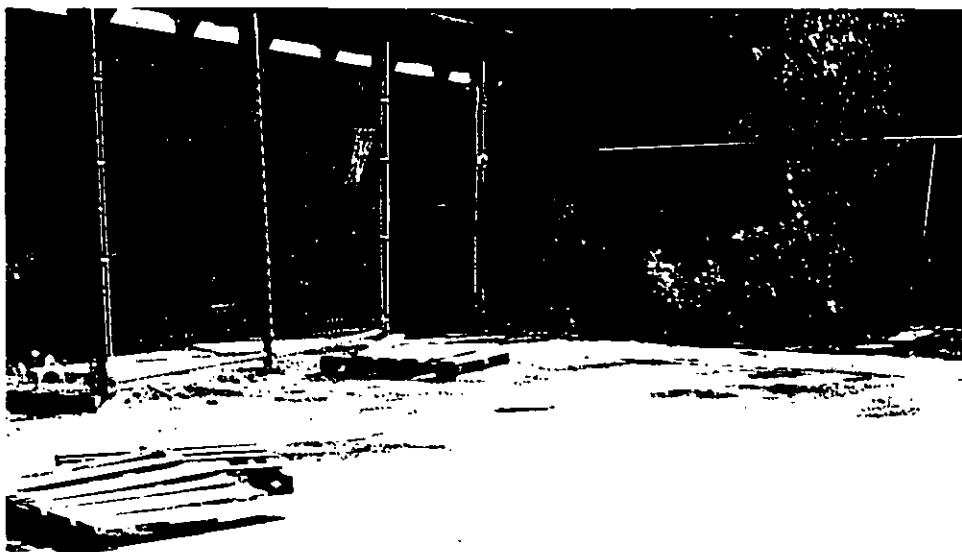
**FRAME NUMBER:** 3 **DATE:** 17 September 1997

**SCENE:** View of former drum storage area along southeastern section of the site (facing southeast).

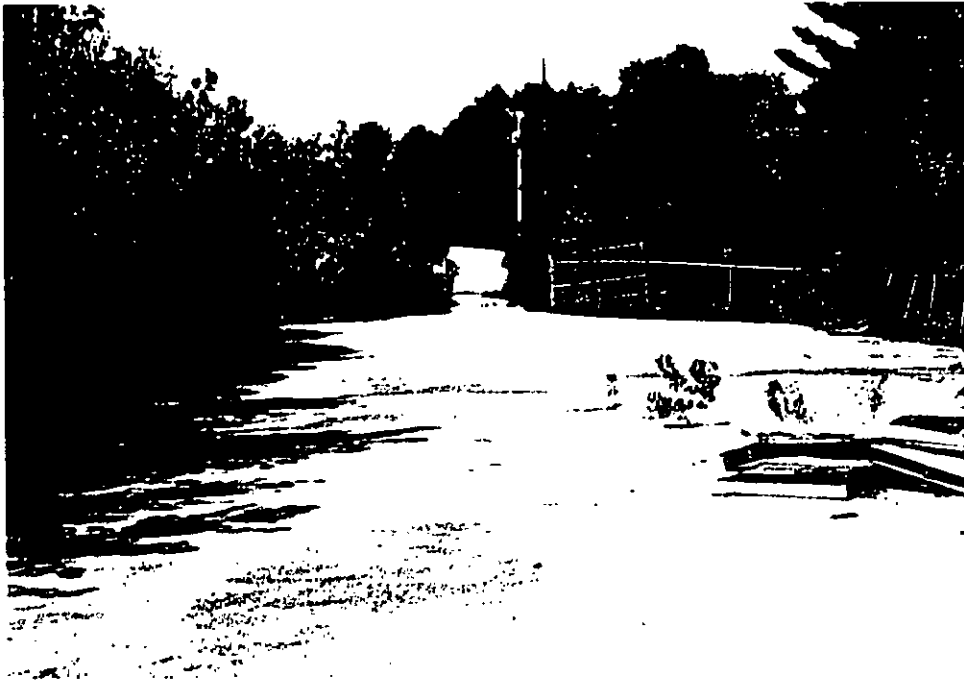
**FRAME NUMBER:** 5 **DATE:** 17 September 1997  
**PHOTOGRAPH BY:** G. Mavris  
**CAMERA:** Olympus **SETTING:** Automatic

**SCENE:** View of paved area and open gate along the northeast corner of the site (facing north).

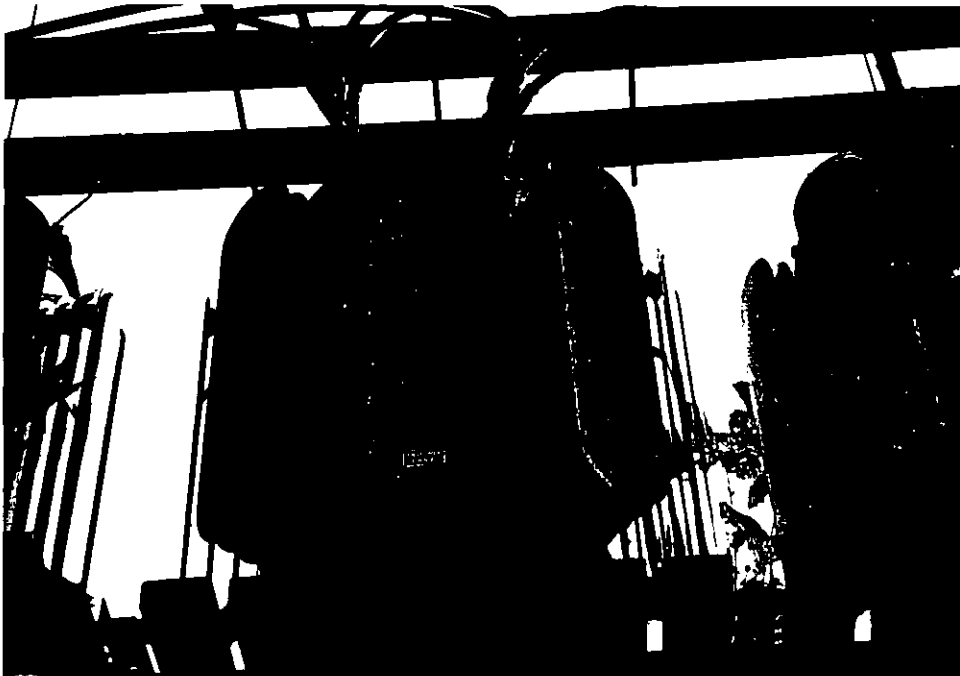
**FRAME NUMBER:** 6 **DATE:** 17 September 1997  
**PHOTOGRAPH BY:** G. Mavris  
**CAMERA:** Olympus **SETTING:** Automatic

Parameter	Quantities/Extent
( ) Landfill:	
(X) Population in Vicinity:	The nearest residences are located on Park Street, approximately 800 feet west of the site.
(X) Wells: ( ) Drinking:	
(X) Monitoring:	No monitoring wells were observed on site.
(X) Other:	Three dry wells and a deep well were noted along the southern and eastern sides of the Jard Company, Inc. building. A hopper and three pole-mounted electrical transformers were also noted south of the building.

**SCENE:** View of pole-mounted transformers along southern side of Jard Company building (facing south).

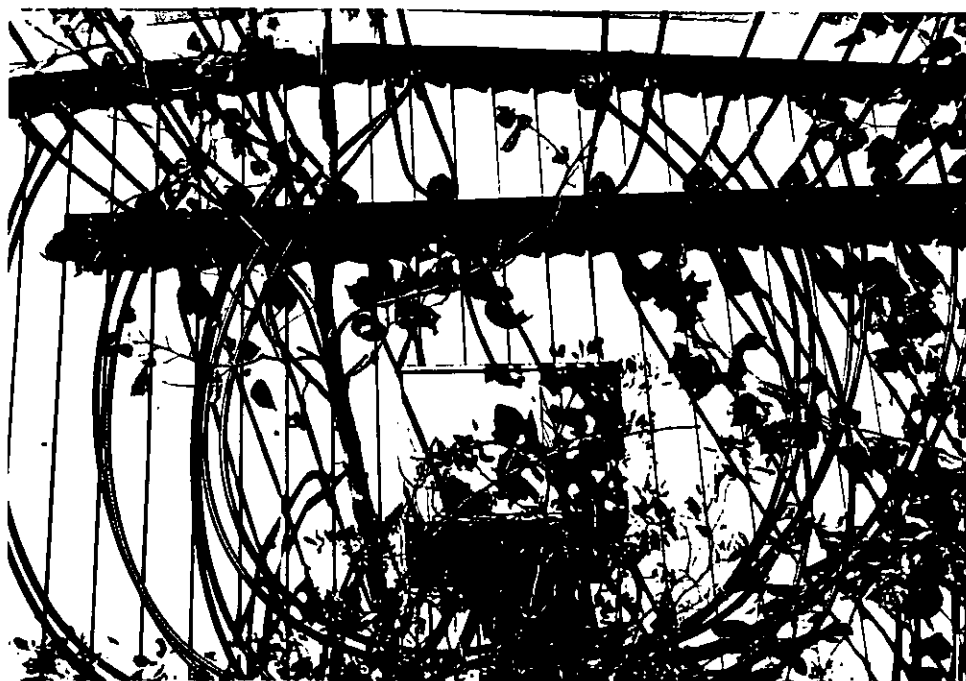
<b>FRAME NUMBER:</b> 7	<b>DATE:</b> 17 September 1997	<b>TIME:</b> 1515	<b>SKY CONDITION:</b> Sunny
<b>PHOTOGRAPH BY:</b> G. Mavris		<b>WITNESS(ES):</b> J. Resca/M.E. Stanton	
<b>CAMERA:</b> Olympus	<b>SETTING:</b> Automatic	<b>FILM TYPE:</b> 35 mm	<b>FILM ROLL:</b> TU 98831

**SCENE:** View of electrical lines leading into Jard building from pole-mounted transformers (facing north).
